GALVANIZED STEEL SUPPLY PLUMBING, TORONTO, ON March 30, 2022

Report No. 0, v.0

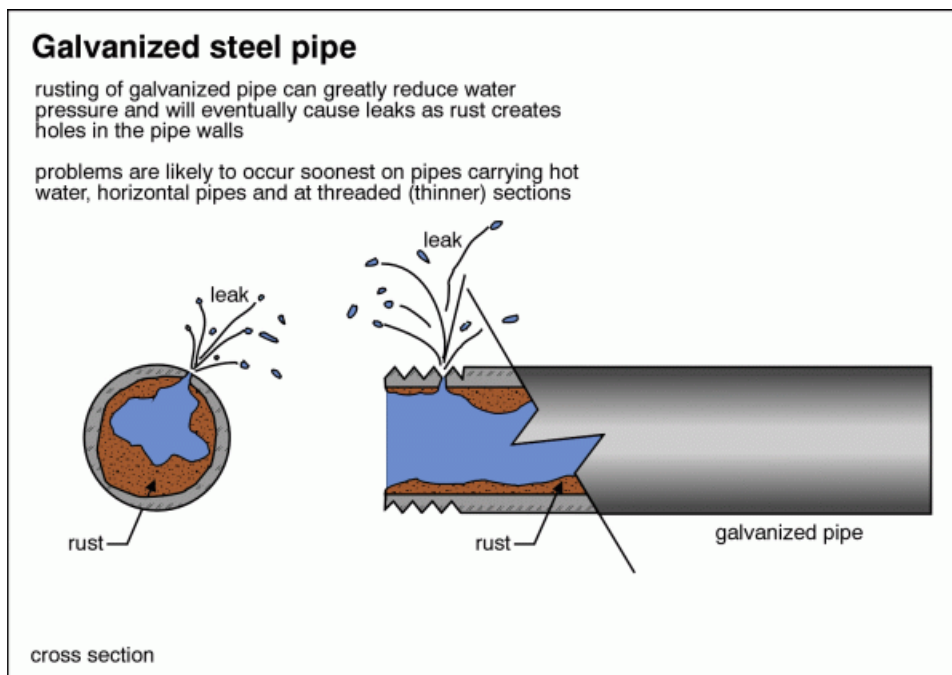
Condition: • [Galvanized steel](#)

This piping is beyond its normal service life. The interior is typically corroded reducing water pressure and volume. Eventually the pipe walls fail and flooding occurs.

Implication(s): Reduced water pressure and volume

Task: Replace

Time: As soon as practical

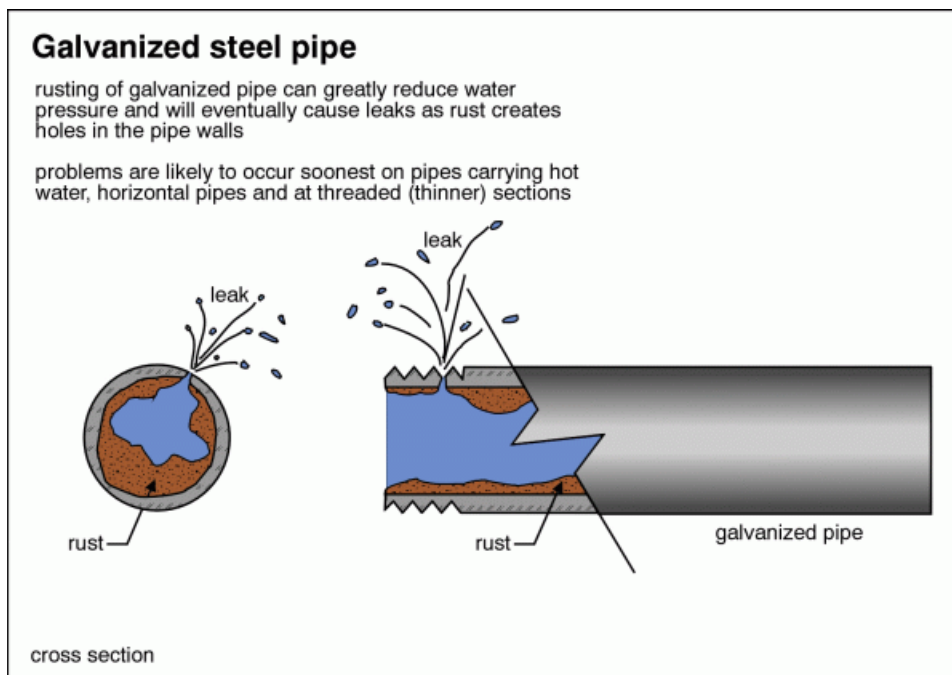
1. Condition: • [Galvanized steel](#)

This piping is beyond its normal service life. The interior is typically corroded reducing water pressure and volume. Eventually the pipe walls fail and flooding occurs.

Implication(s): Reduced water pressure and volume

Task: Replace

Time: As soon as practical
