POLY-B PIPING, TORONTO, UN March 30, 2022

Report No. 0, v.0

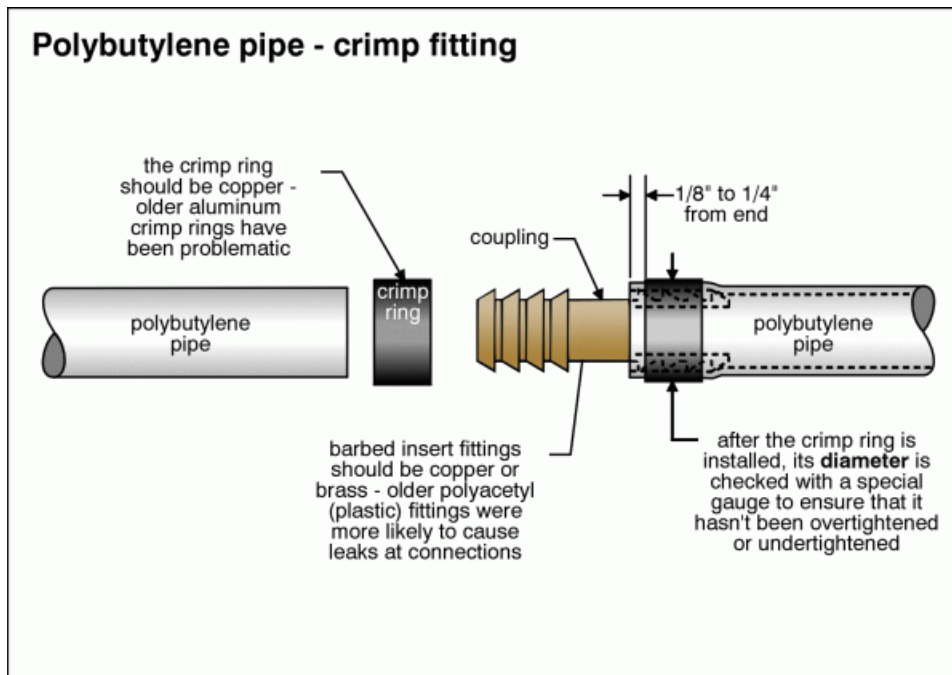
Condition: • [Polybutylene](#)

This plastic piping was manufactured from the late 1970s to the mid 1990s. Failures in both the piping and the fittings have been documented. Many homeowners replace the piping to avoid the risk of water damage from a sudden failure.

Implication(s): Chance of water damage to structure, finishes and contents | Leakage

Task: Further evaluation by a specialist and replace when necessary

Time: As soon as practical

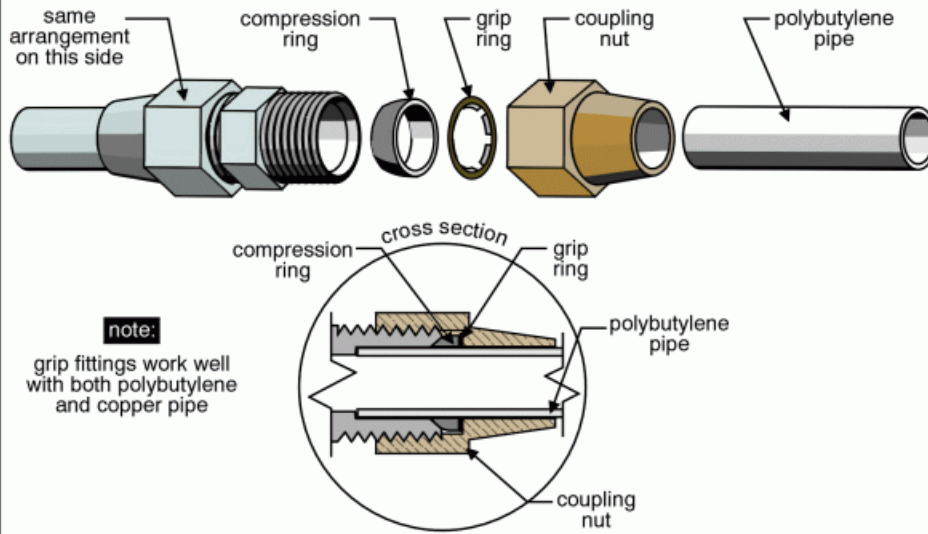
Polybutylene pipe - compression (grip) fitting

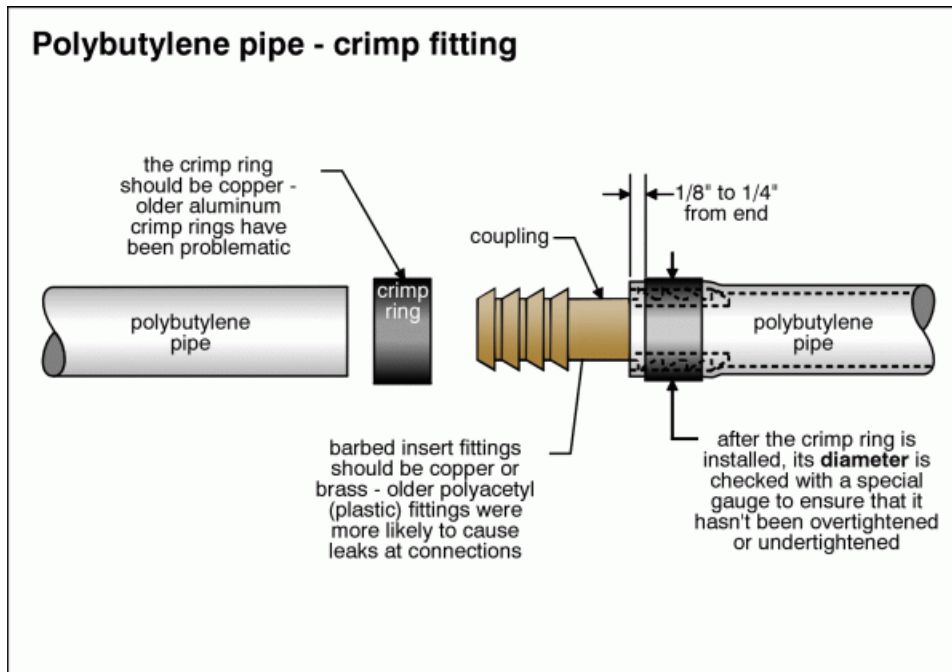
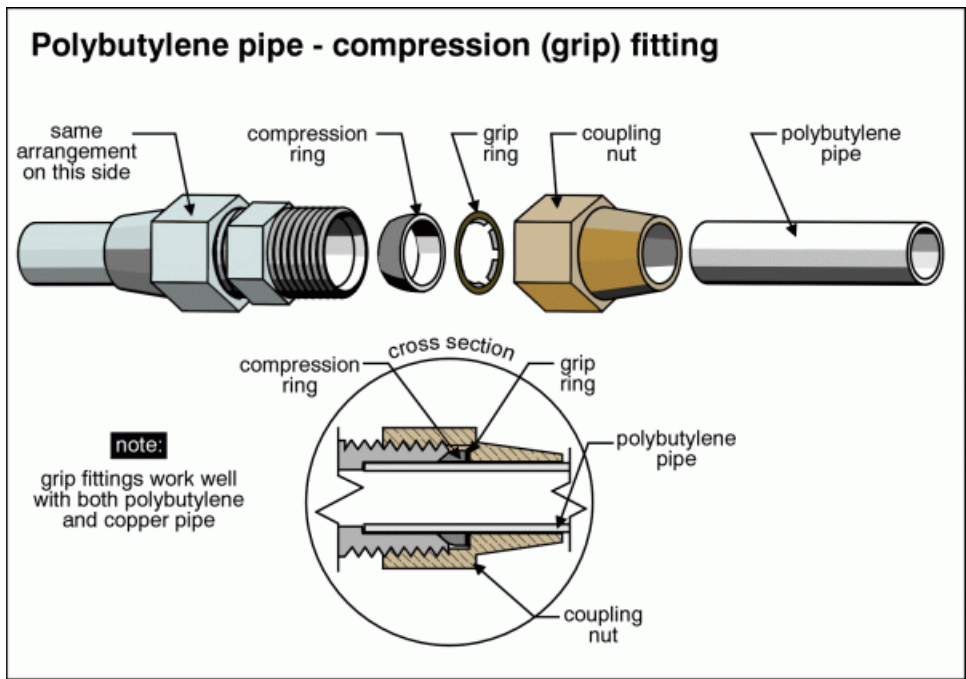
1. Condition: • [Polybutylene](#)

This plastic piping was manufactured from the late 1970s to the mid 1990s. Failures in both the piping and the fittings have been documented. Many homeowners replace the piping to avoid the risk of water damage from a sudden failure.

Implication(s): Chance of water damage to structure, finishes and contents | Leakage

Task: Further evaluation by a specialist and replace when necessary

Time: As soon as practical
